# AHMEDABAD MEASURED DRAWINGS

# HOUSE 1990

# JADA BHAGAT NI POL

Samruddhi Vyas, Nirav Chawda

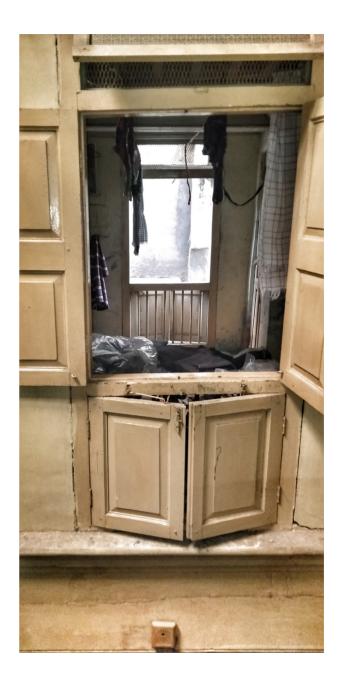
Window-5

Details- Window 5

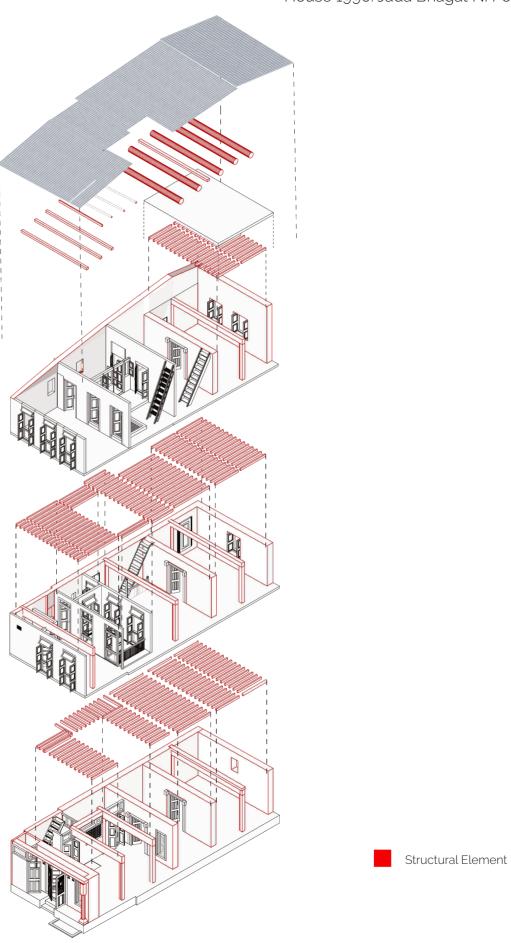
Structural Analysis Model

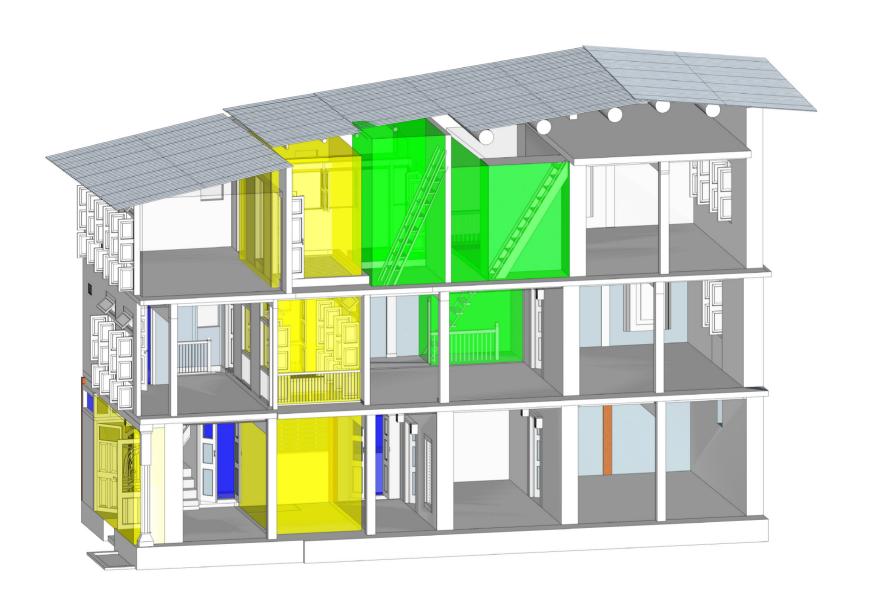
Volumetric Analysis Model

Light Source

Vertical Circulation

Services

Occupied Space

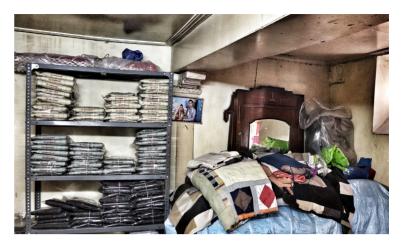
Above: Room on first floor used for storing business goods.

The floors have been divided in a way that each family lives on one floor. The rooms on the first and second floor are used as storage place of the goods.

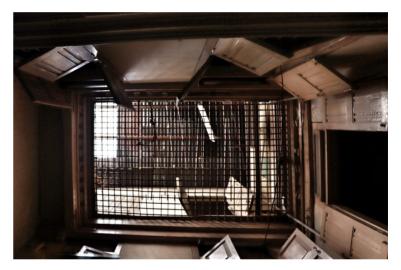
**Above:** View of courtyard from Ground Floor

As the courtyard is the major source of light and ventilation, daily activities and gatherings take place around it.

Three sides of the courtyard are surrounded by windows while fourth side has a railing and the path along it was primarily used for movement but is inaccessible now because of the storage goods around the path.

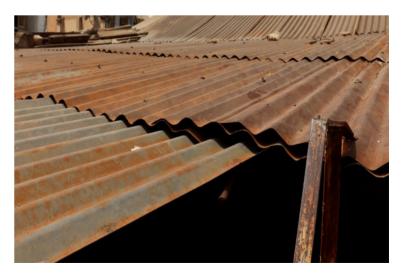
Above: Roof of House

The roof covers the courtyard so a small longitudinal cutout on the roof provides some amount of light. The roof is accessible by staircase. The kids fly kites and play on the roof. During monsoon, the residents cover the cutout with a corrugated sheet which prevents water from coming inside.
